### Materials Letters

# Advanced characterisation of photovoltaics for hail resistance

In this frame, a new research project named ACHILLES"Advanced CHaracterisatIon of photovoLtaics for haiL rESistance", funded by VKF, is in progress with University of Applied Sciences and Arts of Southern Switzerland (involving SUPSI PVlab and DynaMat SUPSI Laboratory), Eastern Switzerland University of Applied Sciences (OST – Institute für Solar Technik), and Swissolar as partners.

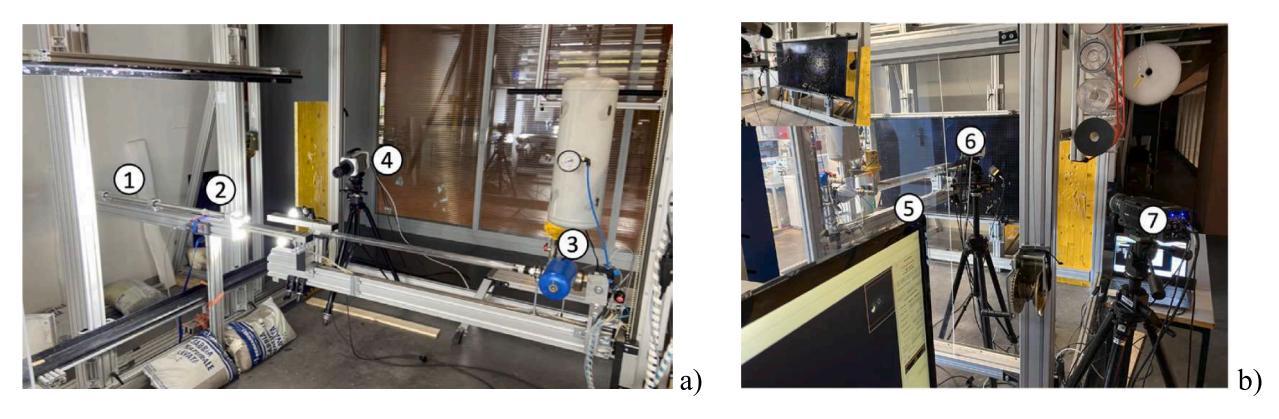
Fig. 1. Setup for impulse recording (load vs time) of ice balls on a rigid aluminium bar (a) and for ice ball impact on a the PV panel (b).

hail. In the initial phase of the research, a Hopkinson bar was employed to capture the waveform resulting from the collision of the ice projectiles with the instrumented aluminium bar. The setup shown in Fig. 1a consists of an aluminium bar (1) with diameter of 30 mm and 1.5 m in length; strain-gauge station (2); a gas gun (3) for ice ball acceleration; Photron NOVA S12 fast camera (4) for fast (B/W) image recordings (12800 fps at full resolution of  $1024 \times 1024$  pixels). A PC station for fast camera recording synchronisation and an acquisition system (HBM Gen2i) for data recording at 1Msample and acquisition time step of  $1 \cdot 10^{-6}$  s.

With reference to Fig. 1b, in order to study the effect of the ice ball impact on PV panel the gas gun (5) is positioned in front of the PV panel and the impact was recorded by Photron NOVA S12 fast camera 06 and IDT Y4-S3 fast camera (7) (5100 fps at full resolution of  $1024 \times 1024$  pixels) obtaining the cracking process during the PV panel failure.

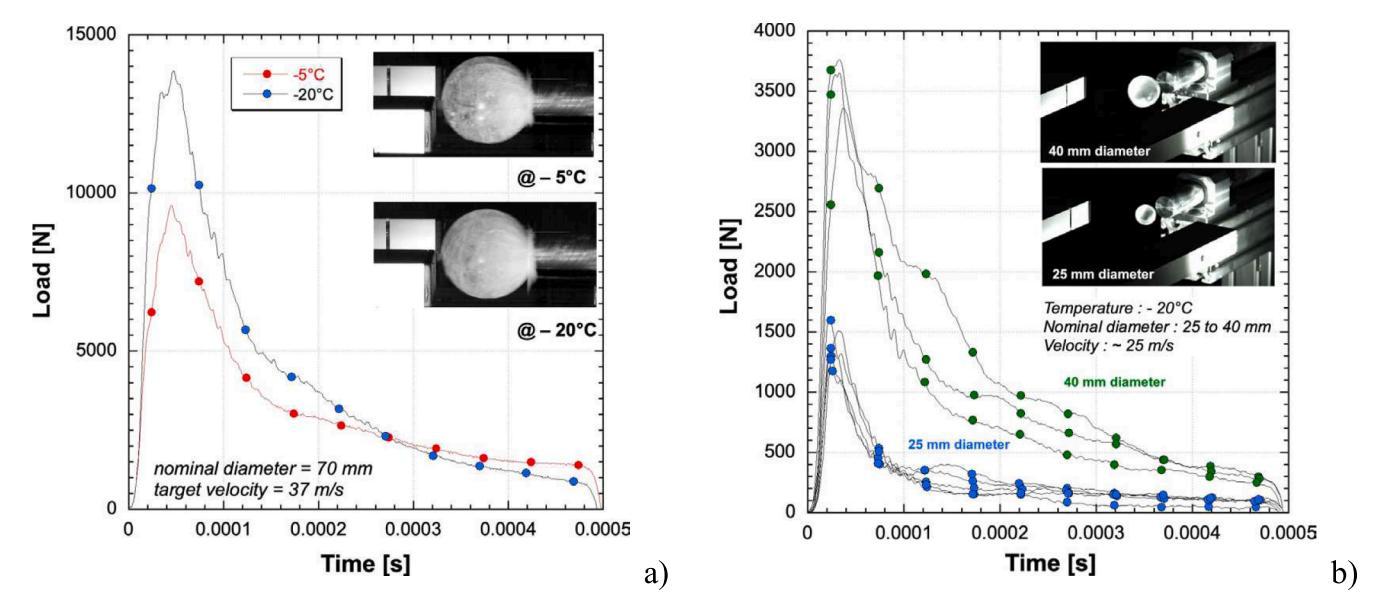
Fig. 2. Load versus time curves: a) specimens with 70 mm in diameter at -5 °C and -20 °C; comparison between 40 mm and 25 mm diameter specimens at -20 °C.

same velocity and at two different frozen temperatures, -5 °C and -20 °C, to compare loading versus time response. Table 1 summarises the average results under different conditions. Specifically, the specimen temperature and mass were reported, as well as the diameter of the specimen. In addition to the results regarding velocity, maximum load registered on the Hopkinson bar, and time when it occurred. In general, monotonically increasing trends can be observed for individual test groups. However, there appears to be some dispersion in the overall data. The lower temperature (-20 °C) causes an increase in peak load and a reduction in fracture time.

By comparing the average values of samples having 40 mm diameters, the temperature decrease causes a double loading rate, resulting in a higher stress rate on the bar, i.e. at -5 °C the stress rate is around 74 GPa/s and at -20 °C about 150 GPa/s. In the case of 25, 40, and 70 mm ice balls at -20 °C, peak forces are approximately 70 %, 59 %, and 44 % higher than those at -5 °C at the same velocities. For 25, 40, and 70 mm, ice reaches its peak force in a shorter amount of time at -20 °C, which is 30 %, 21 % and 2 % lower than at -5 °C. Fig. 2a shows the comparison between the load versus time curves of 70 mm diameter samples at two temperatures. Decreasing the sample temperature will cause an increase in the peak force, and a reduction in the time it takes for the peak force to be reached. A slightly steeper curve is also visible before the peak for ice frozen at -20 °C. Fig. 2b provides the comparison between the load versus time curves at  $-20\ ^\circ C$  for 25 and 40 mm specimens. Fig. 3 shows photos taken during the impact of three diameters of ice balls. Taking a look at the last sequence, it shows the impact of the ice ball on the PV panel, which highlights the cracking that occurs as a result.

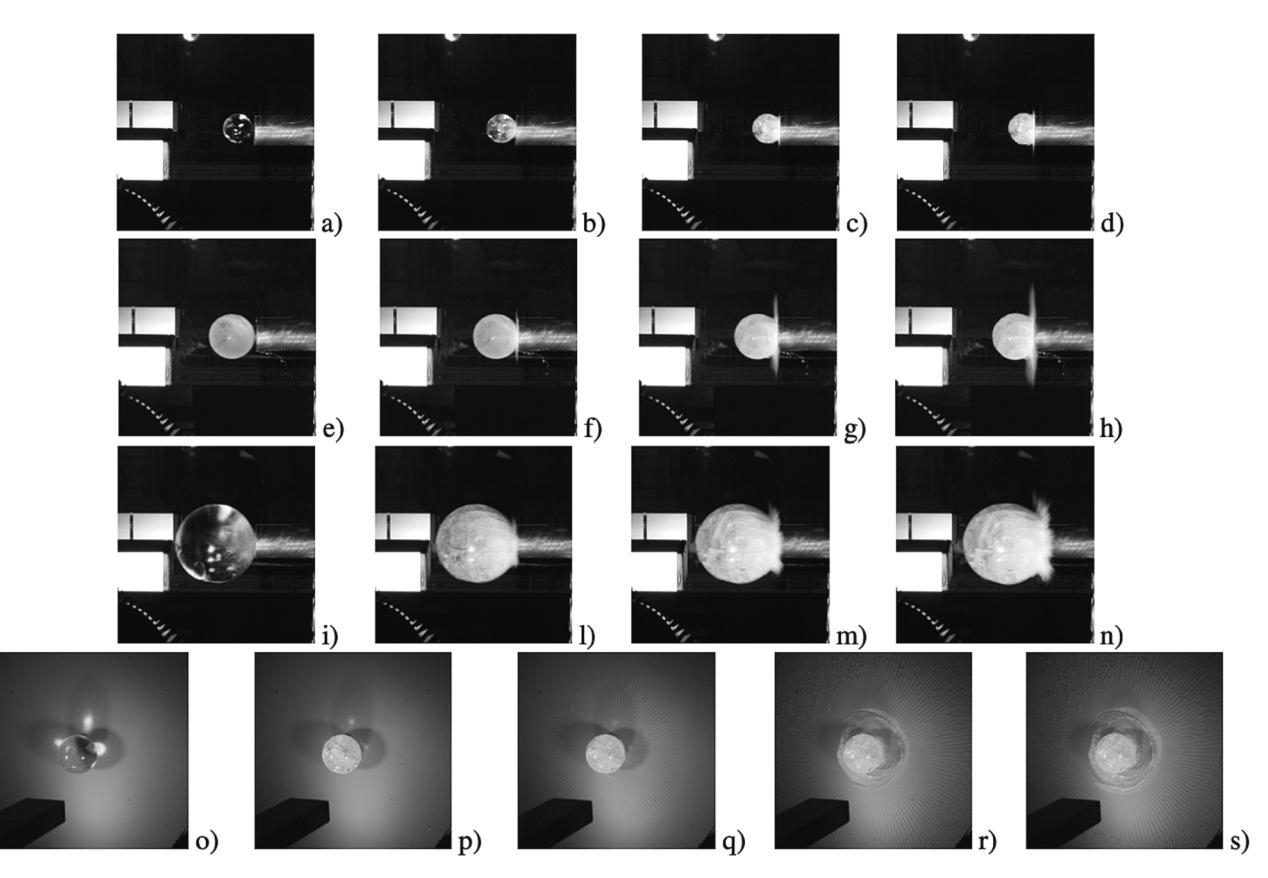
Fig. 3. Images of the spherical ice specimens' impact on the Hopkinson bar (a-n) and on PV panel (o-s) (12800 fps).
